REPORT NUMBER: 201U-CAL-05-04

**SAFETY COMPLIANCE TESTING FOR FMVSS 201
OCCUPANT PROTECTION IN INTERIOR IMPACT
UPPER INTERIOR HEAD IMPACT PROTECTION**

**GENERAL MOTORS OF CANADA LTD.
2005 BUICK LACROSSE 4-DOOR SEDAN**

NHTSA NUMBER: C50104

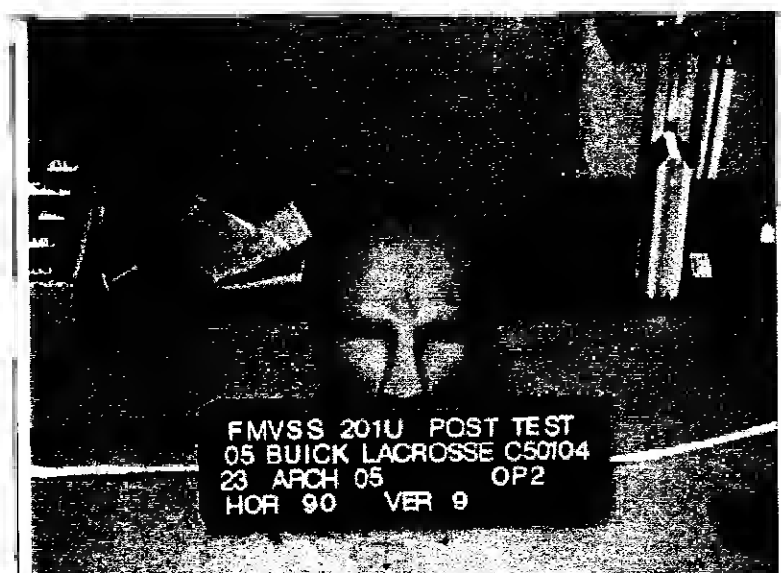
POST-IMPACT OP2 HEADFORM

Free Motion HIC	801.5
HIC(d)	771.1
Impact Velocity (kph)	23.54
HIC T1 (msec)	4.3
HIC T2 (msec)	10.6

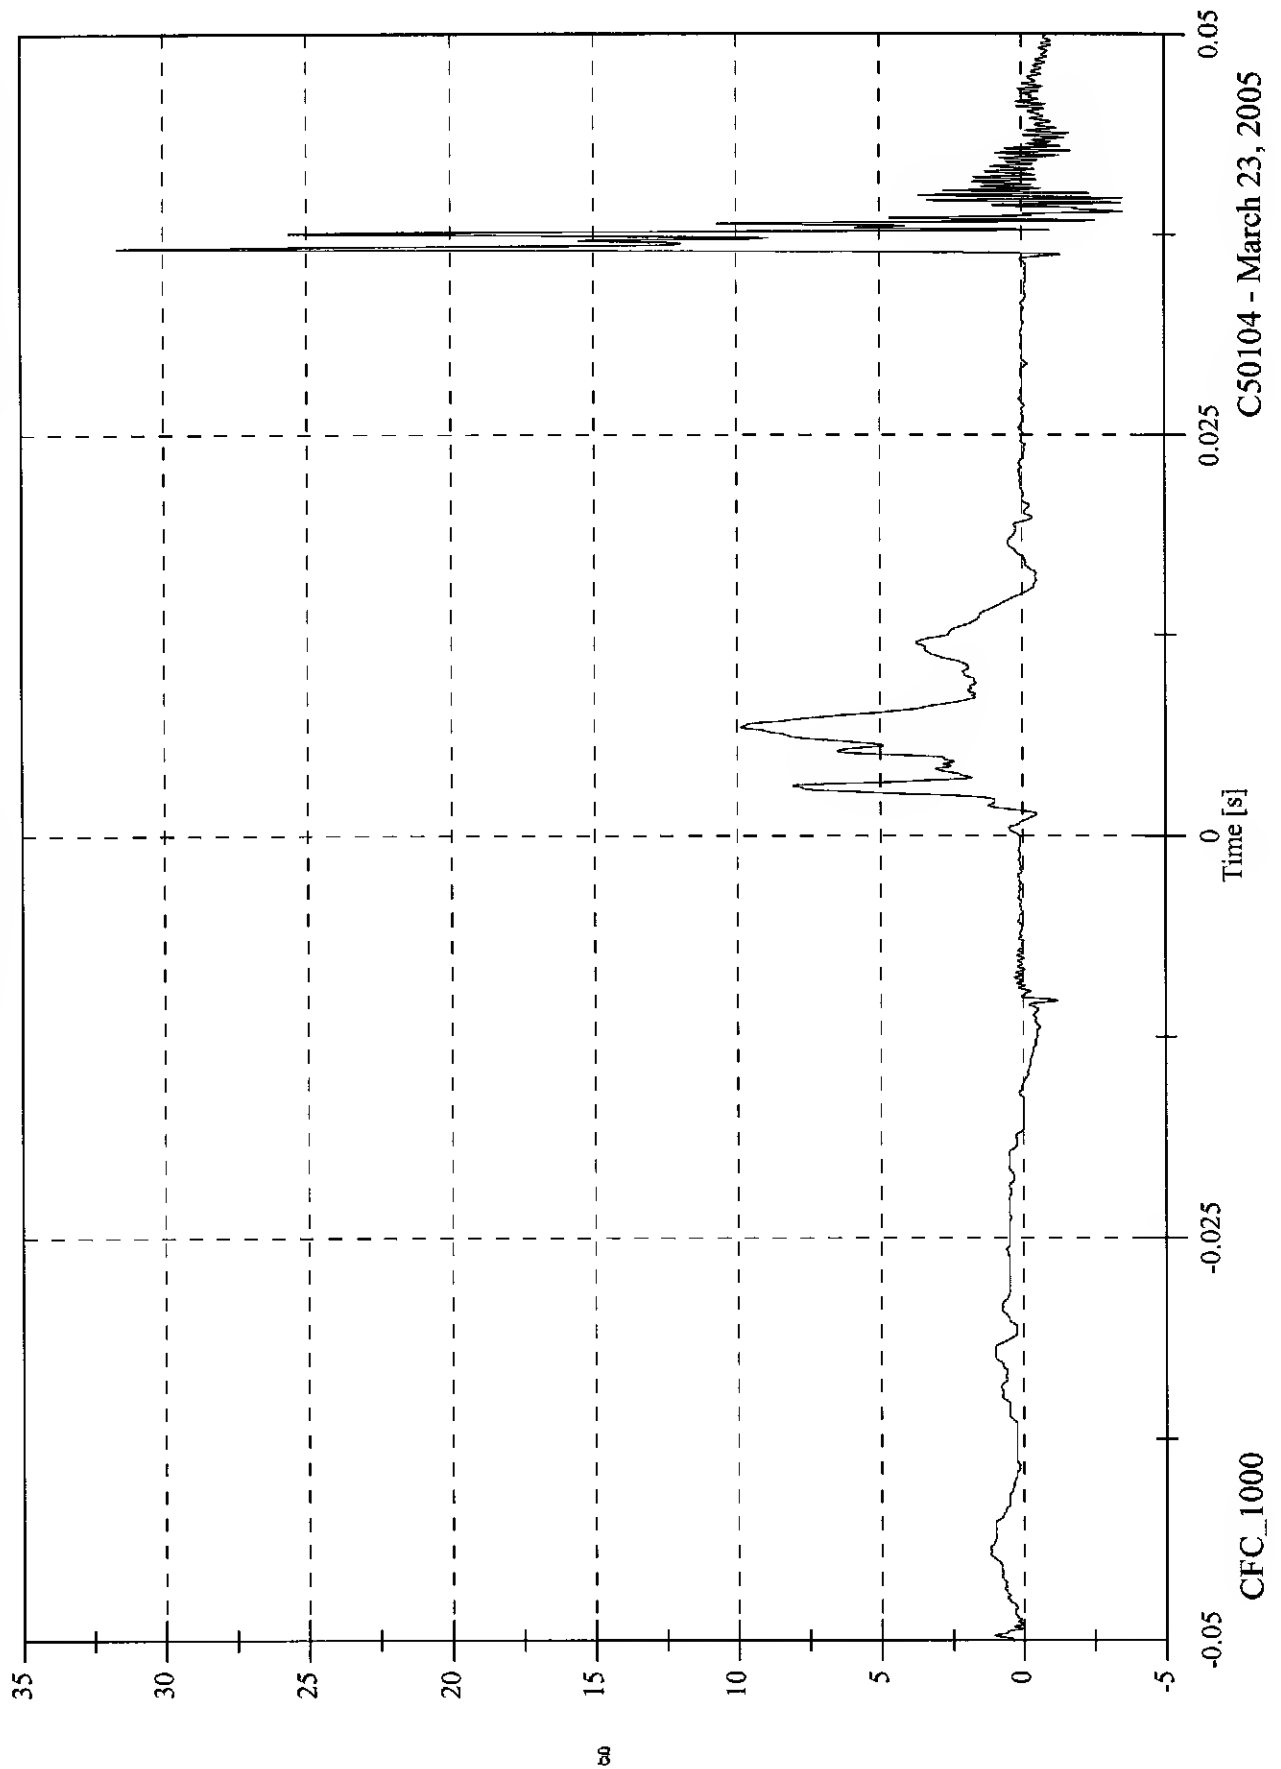
Max: 31.6 [g] at 0.037 [s]

Min: -3.5 [g] at 0.039 [s]

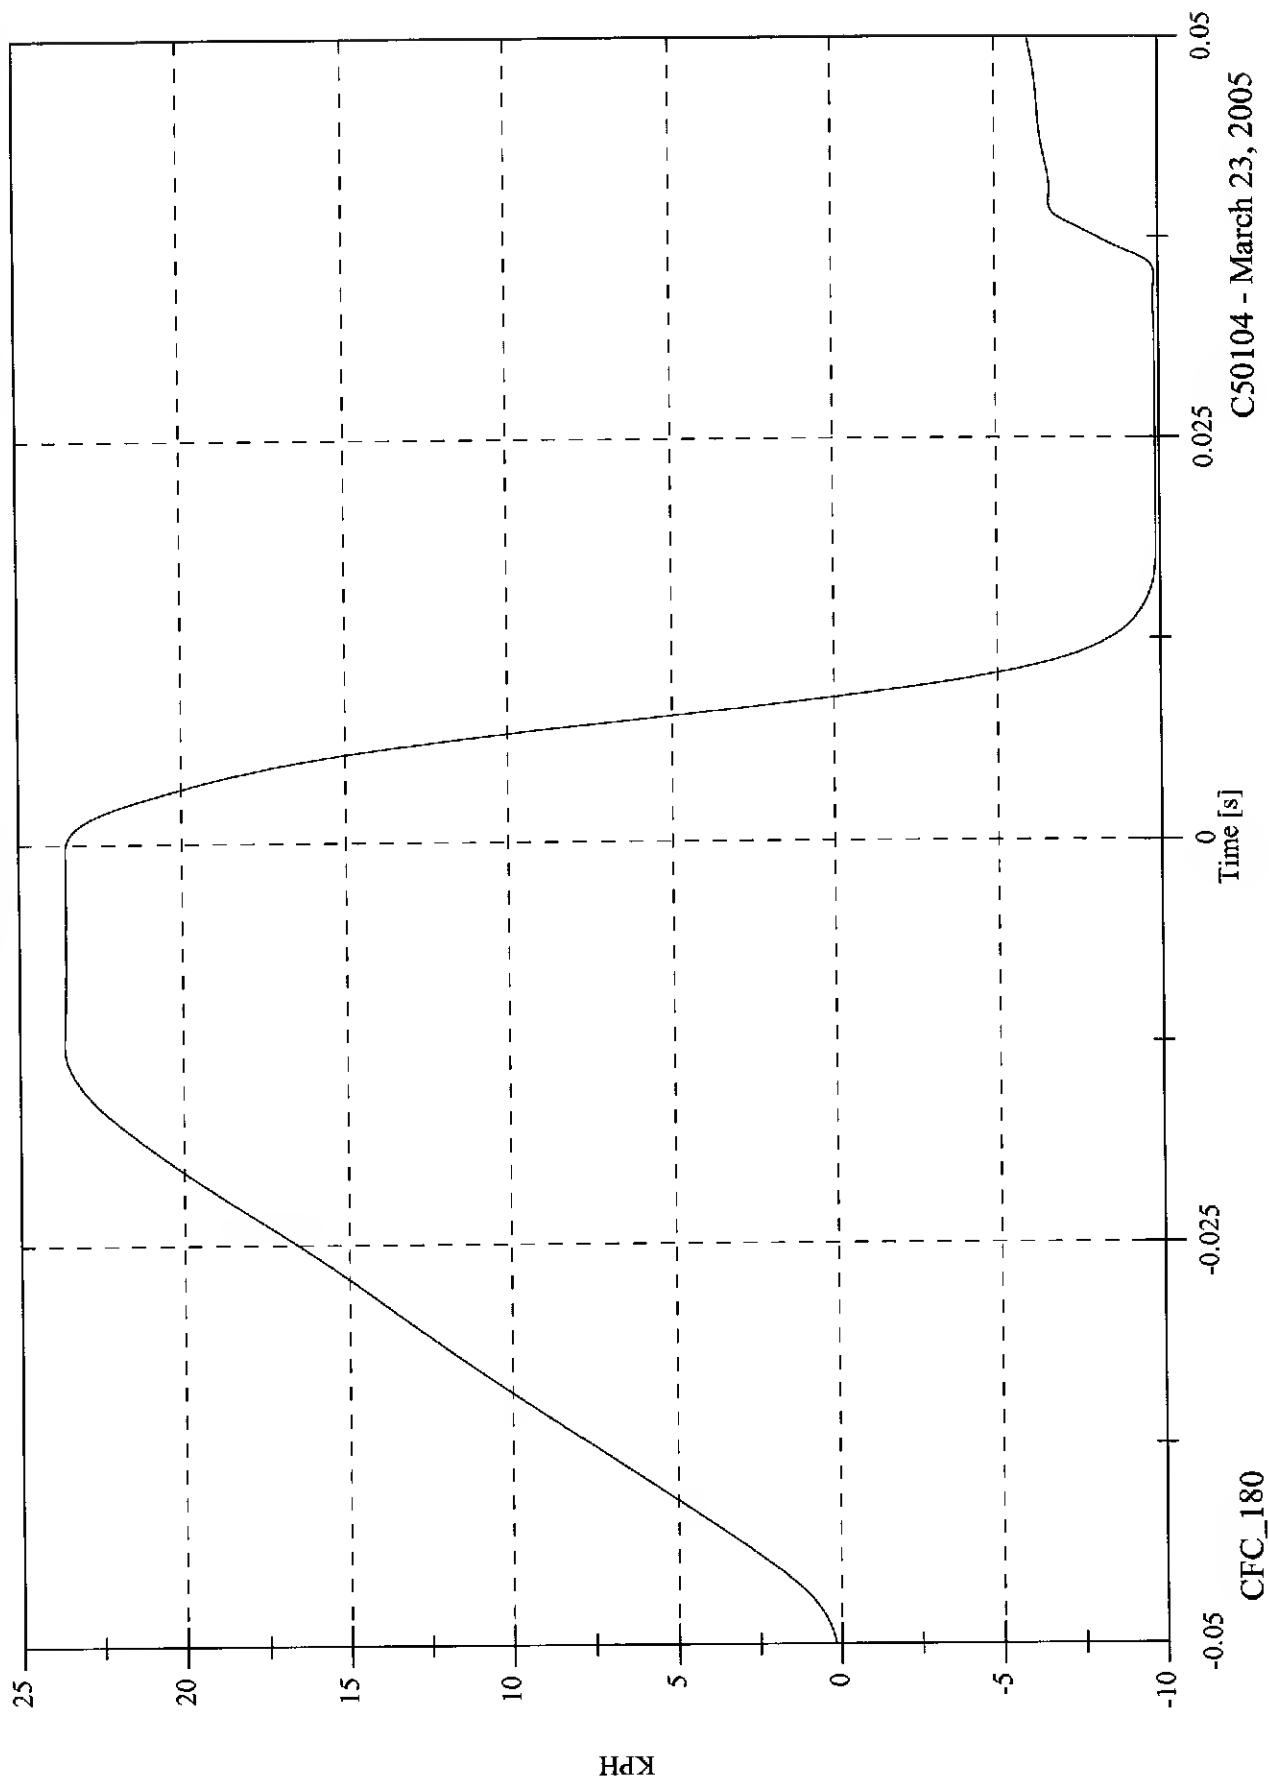
Max: 23.6 [KPH] at -0.012 [s]

Min: -9.9 [KPH] at 0.019 [s]

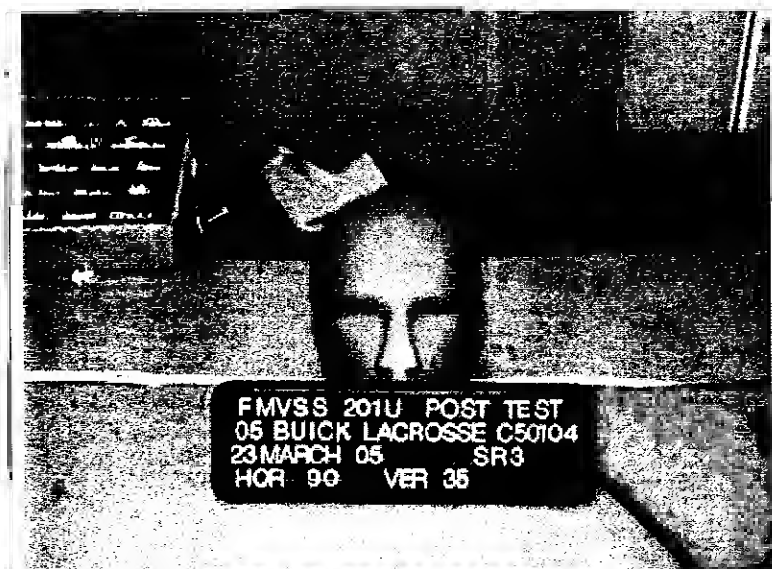
POST-IMPACT SR3 HEADFORM

Free Motion HIC	781
HIC(d)	755.6
Impact Velocity (kph)	23.36
HIC T1 (msec)	2.9
HIC T2 (msec)	8.8

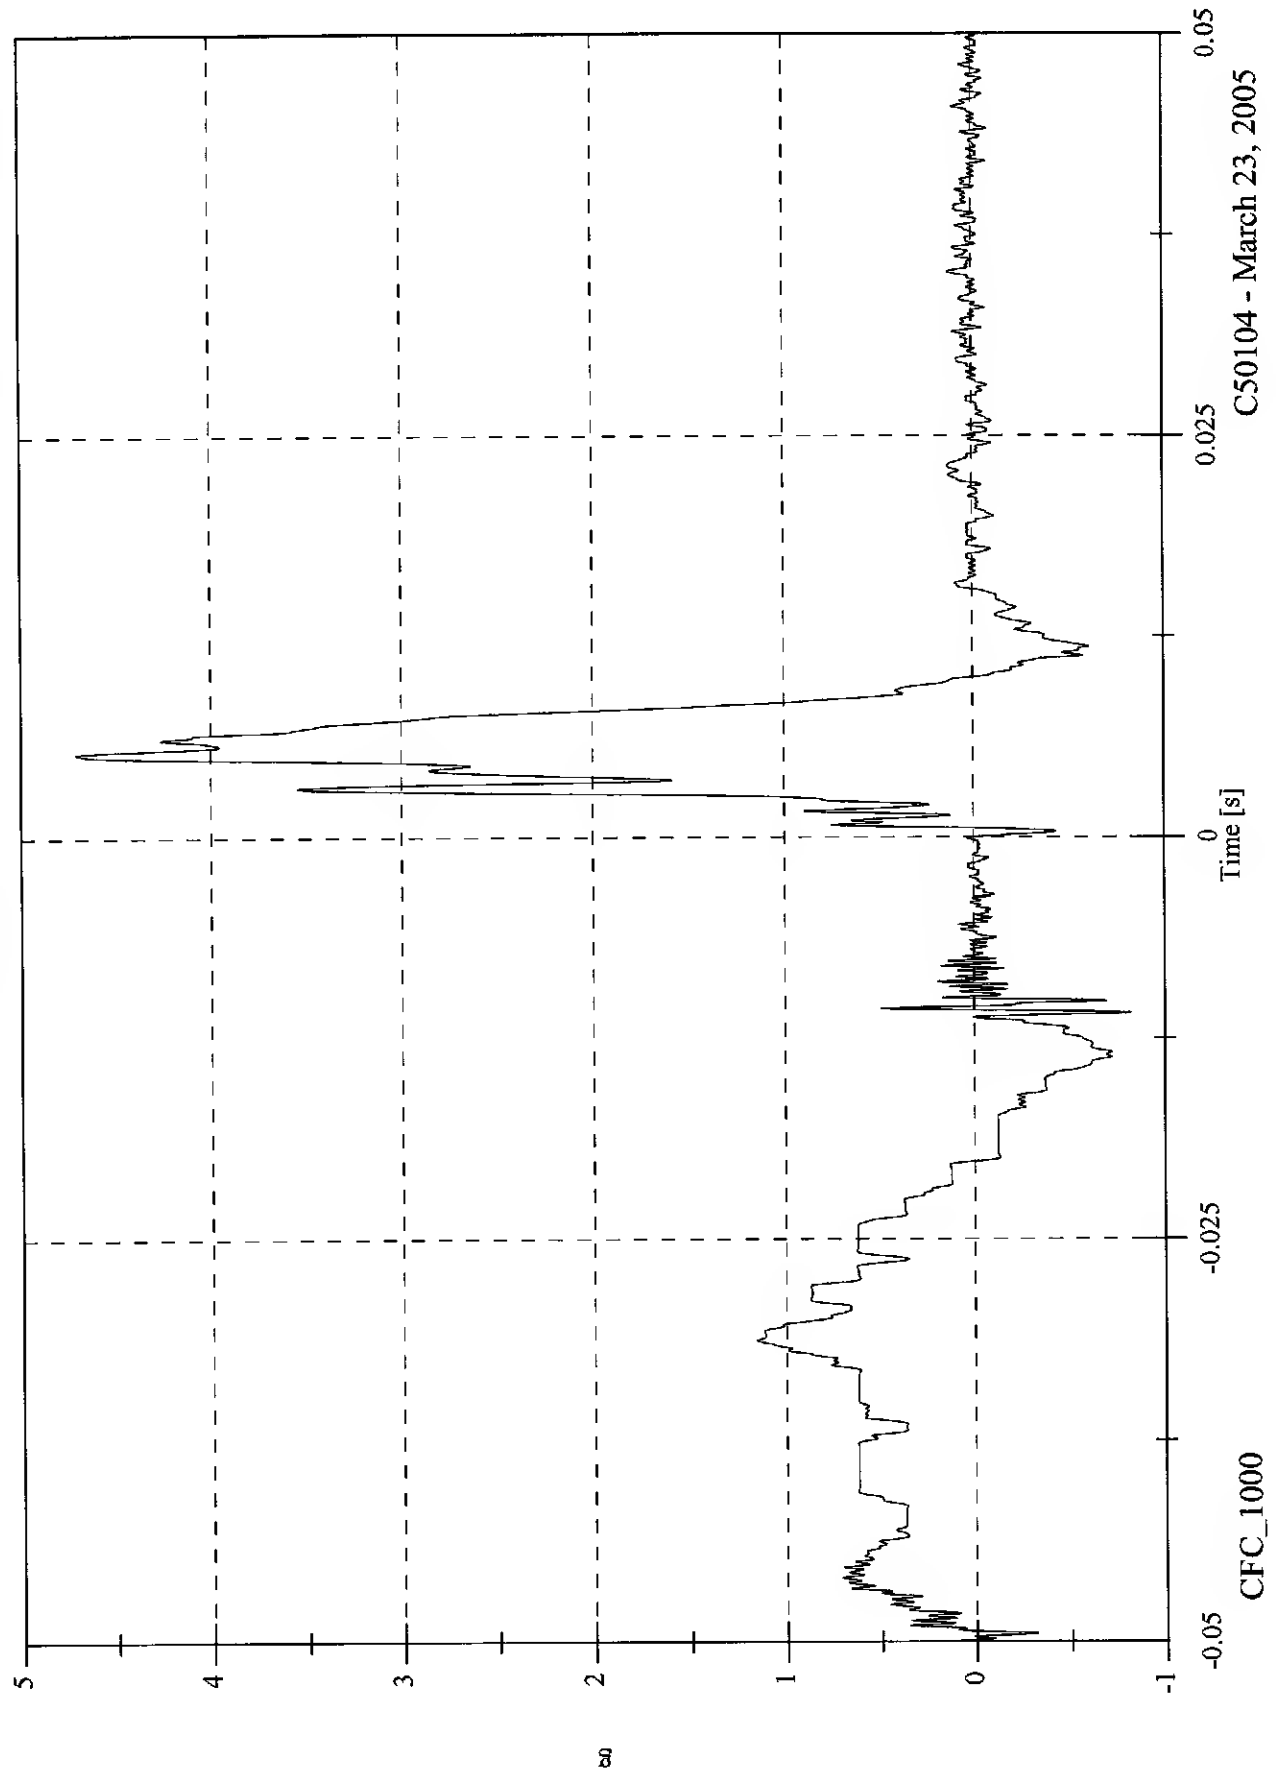
FMVSS 201U IMPACT TEST - 2005 Buick Lacrosse
Headform Y Acceleration

Max: 4.7 [g] at 0.005 [s]
Min: -0.8 [g] at -0.011 [s]

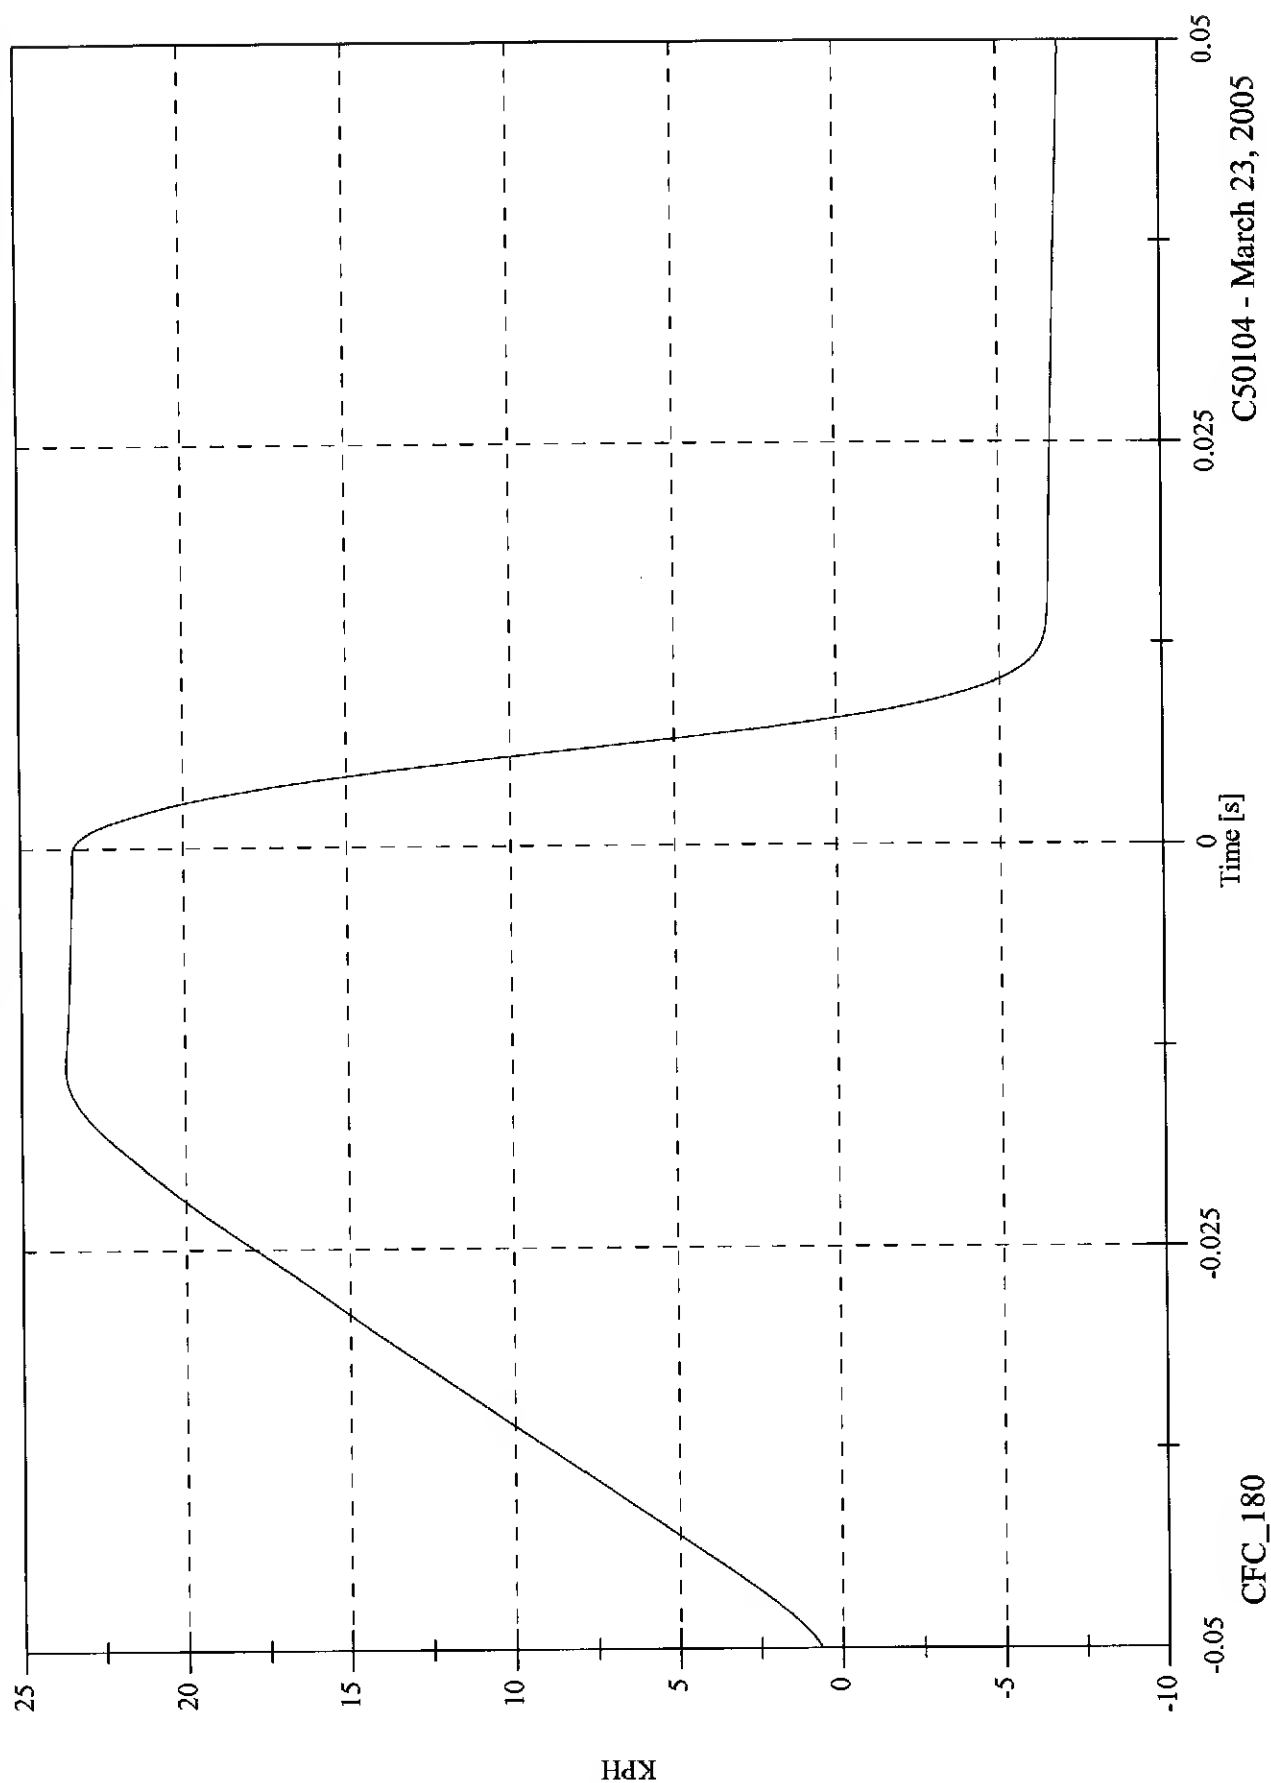
FMVSS 201U IMPACT TEST - 2005 Buick Lacrosse

Headform Velocity

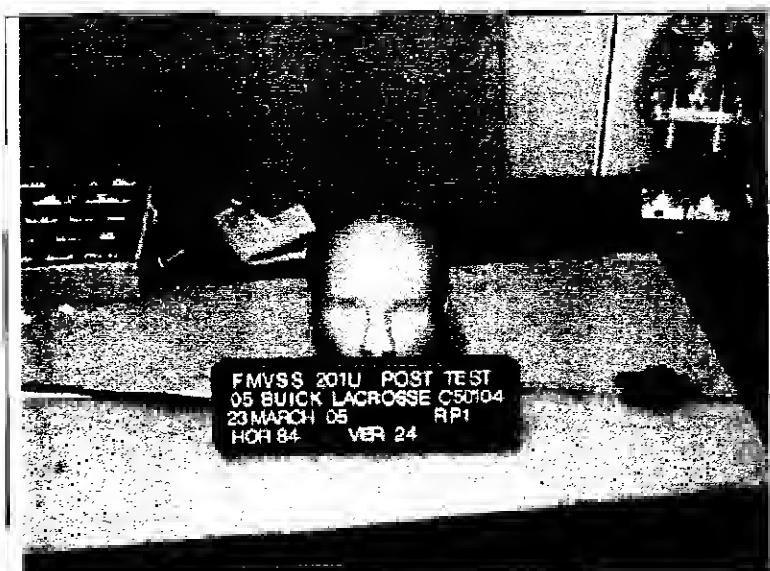
POST-IMPACT RP1 HEADFORM

Free Motion HIC	775.5
HIC(d)	751.5
Impact Velocity (kph)	23.66
HIC T1 (msec)	1.6
HIC T2 (msec)	7.7

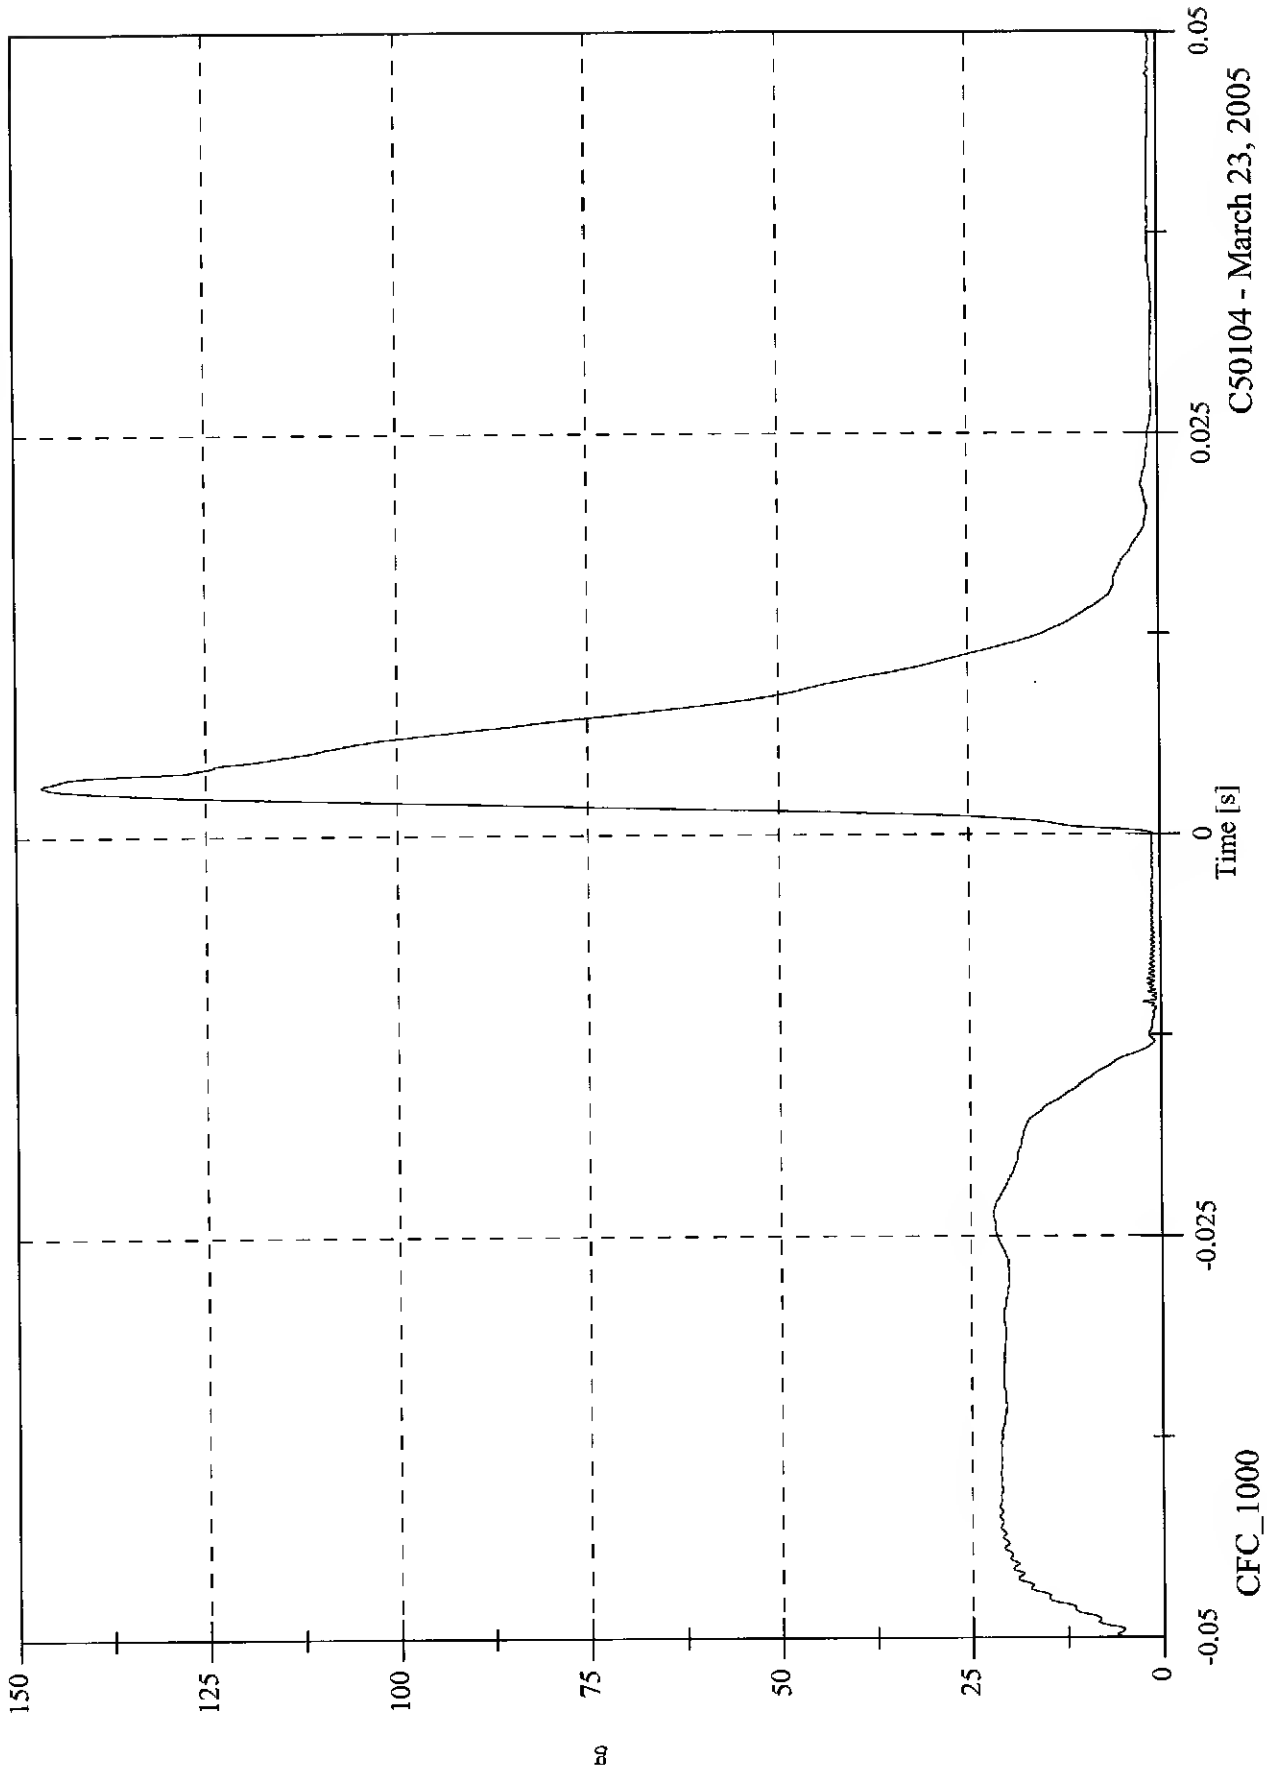
Headform Resultant

Max: 146.5 [g] at 0.003 [s]
Min: 0.6 [g] at -0.010 [s]

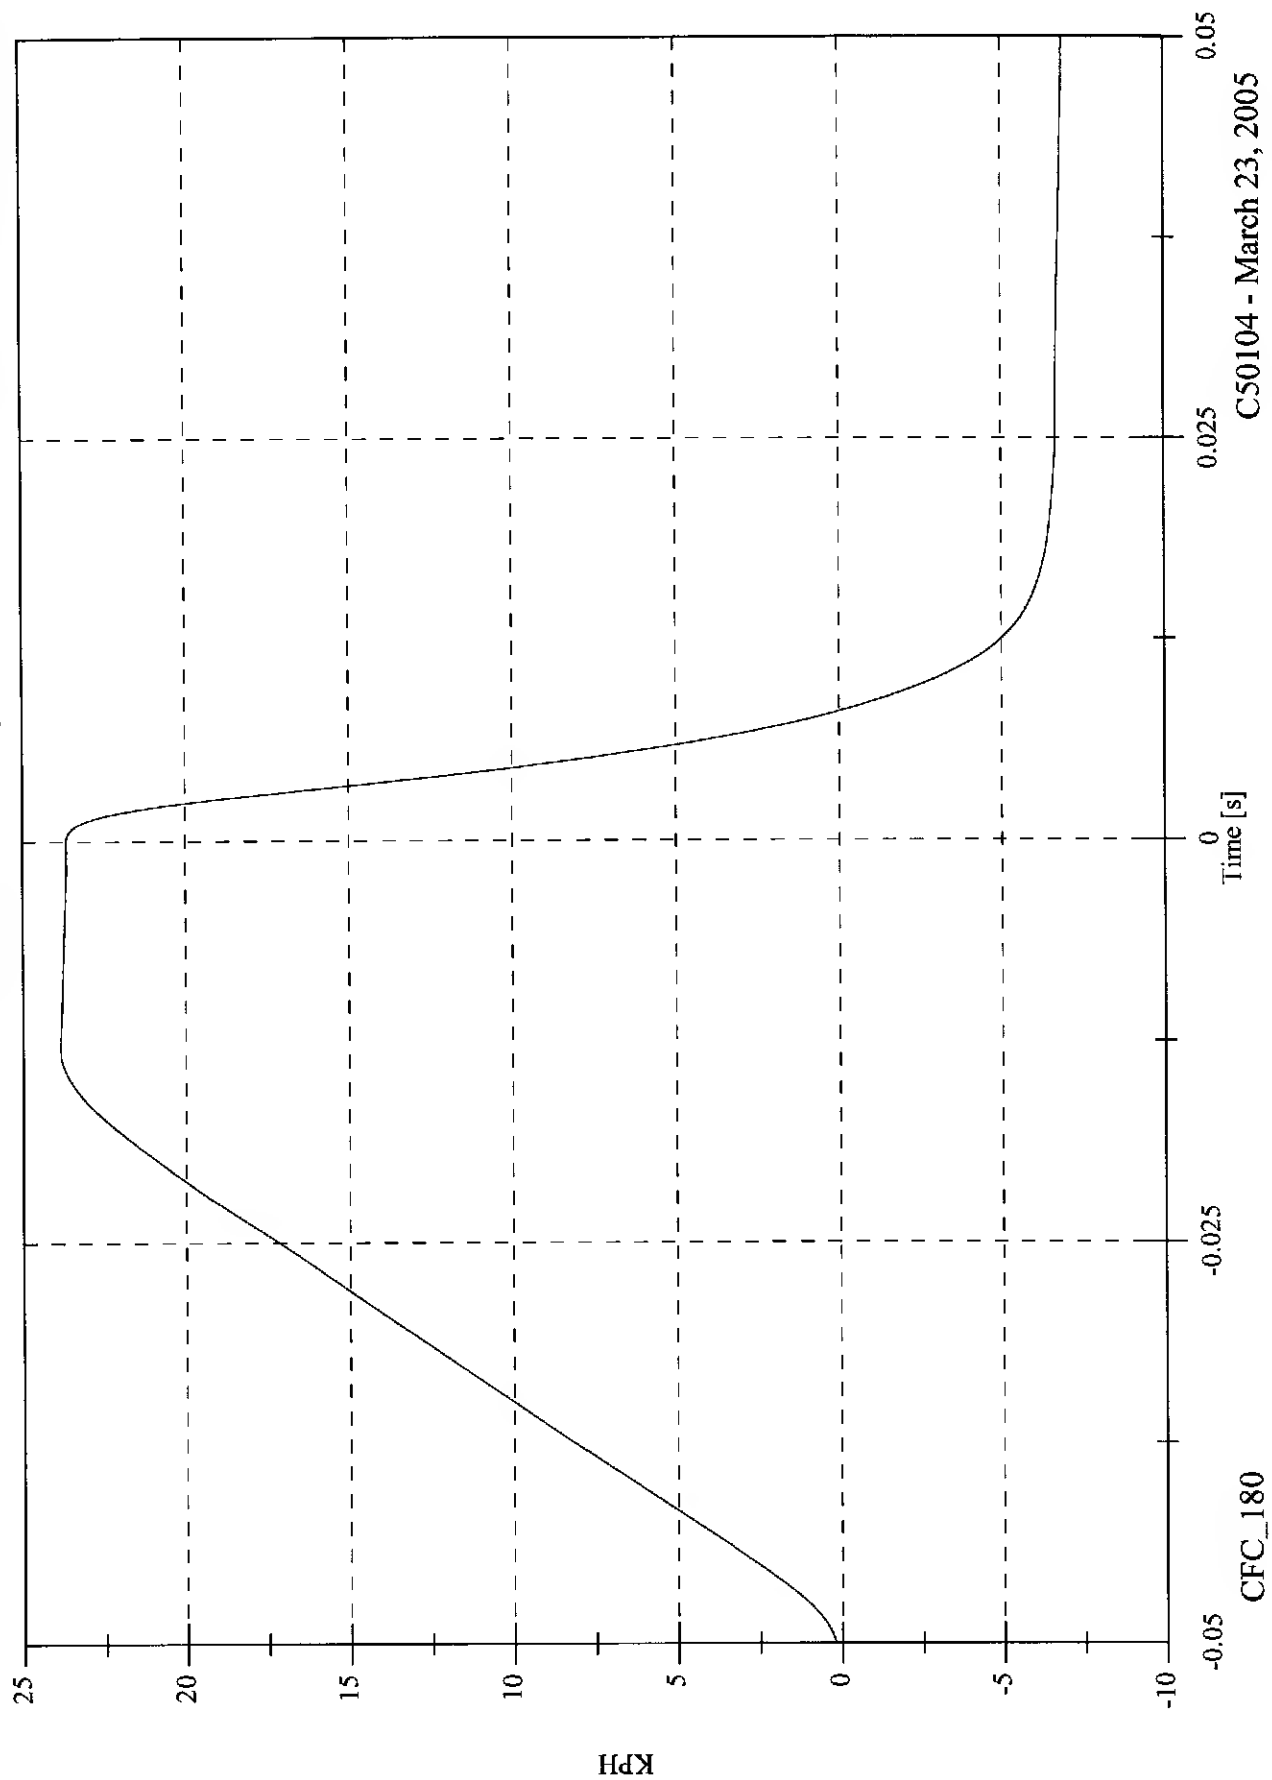
Max: 23.9 [KPH] at -0.013 [s]
Min: -6.9 [KPH] at 0.050 [s]

FMVSS 201U IMPACT TEST - 2005 Buick Lacrosse

Headform Velocity

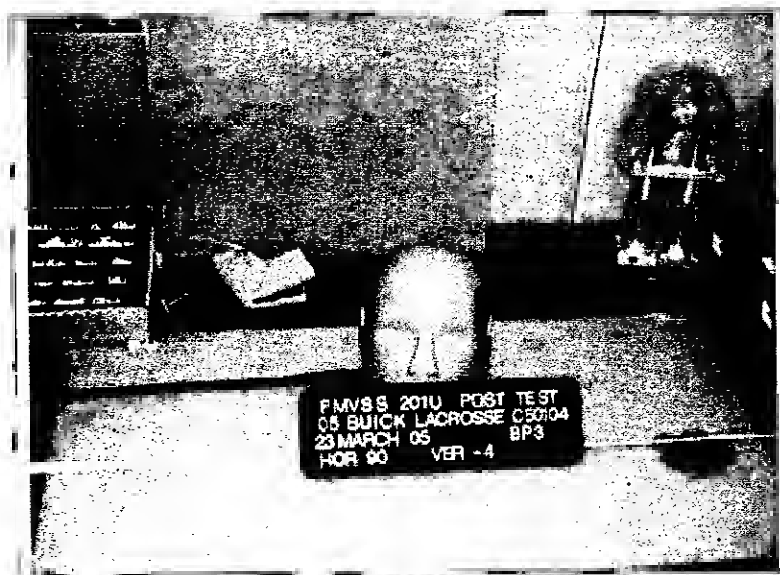
POST-IMPACT BP3 HEADFORM

Free Motion HIC	350.1
HIC(d)	430.5
Impact Velocity (kph)	23.64
HIC T1 (msec)	2.6
HIC T2 (msec)	12.5

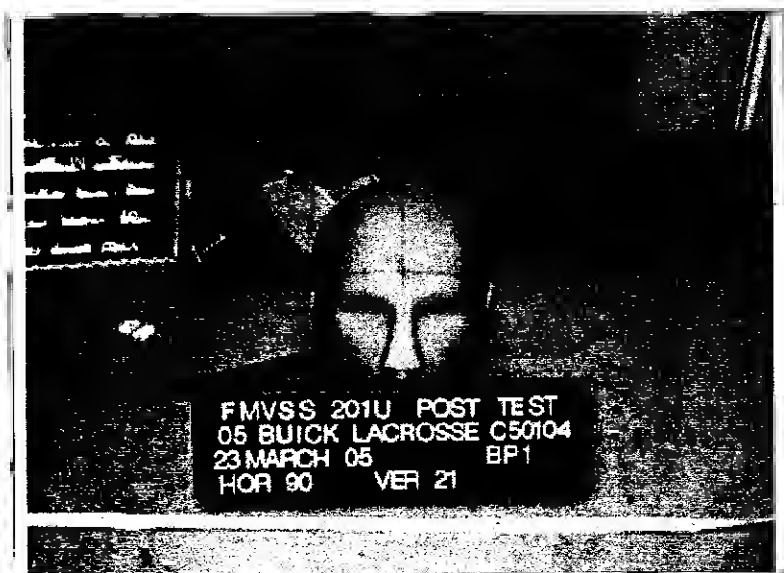
POST-IMPACT BP1 HEADFORM

Free Motion HIC	711.2
HIC(d)	703
Impact Velocity (kph)	23.72
HIC T1 (msec)	2.4
HIC T2 (msec)	9.3

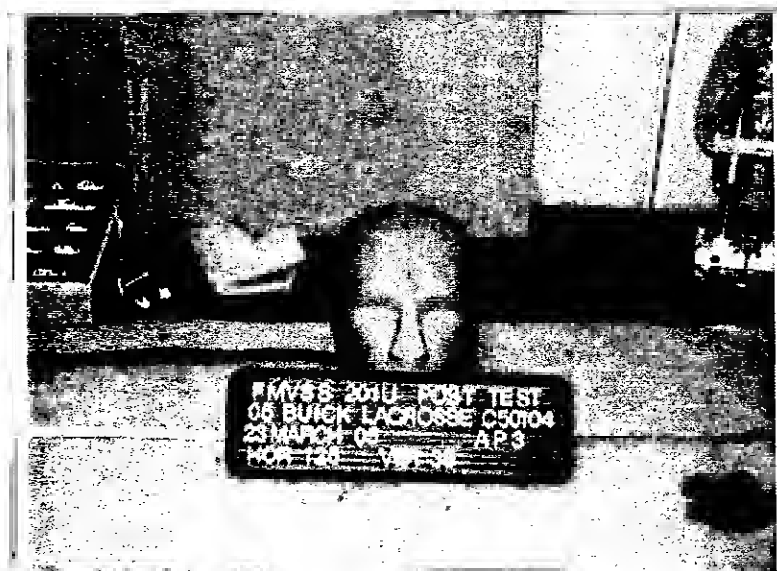
POST-IMPACT AP3 HEADFORM

Free Motion HIC	668.1
HIC(d)	664.9
Impact Velocity (kph)	23.89
HIC T1 (msec)	1.7
HIC T2 (msec)	7.2

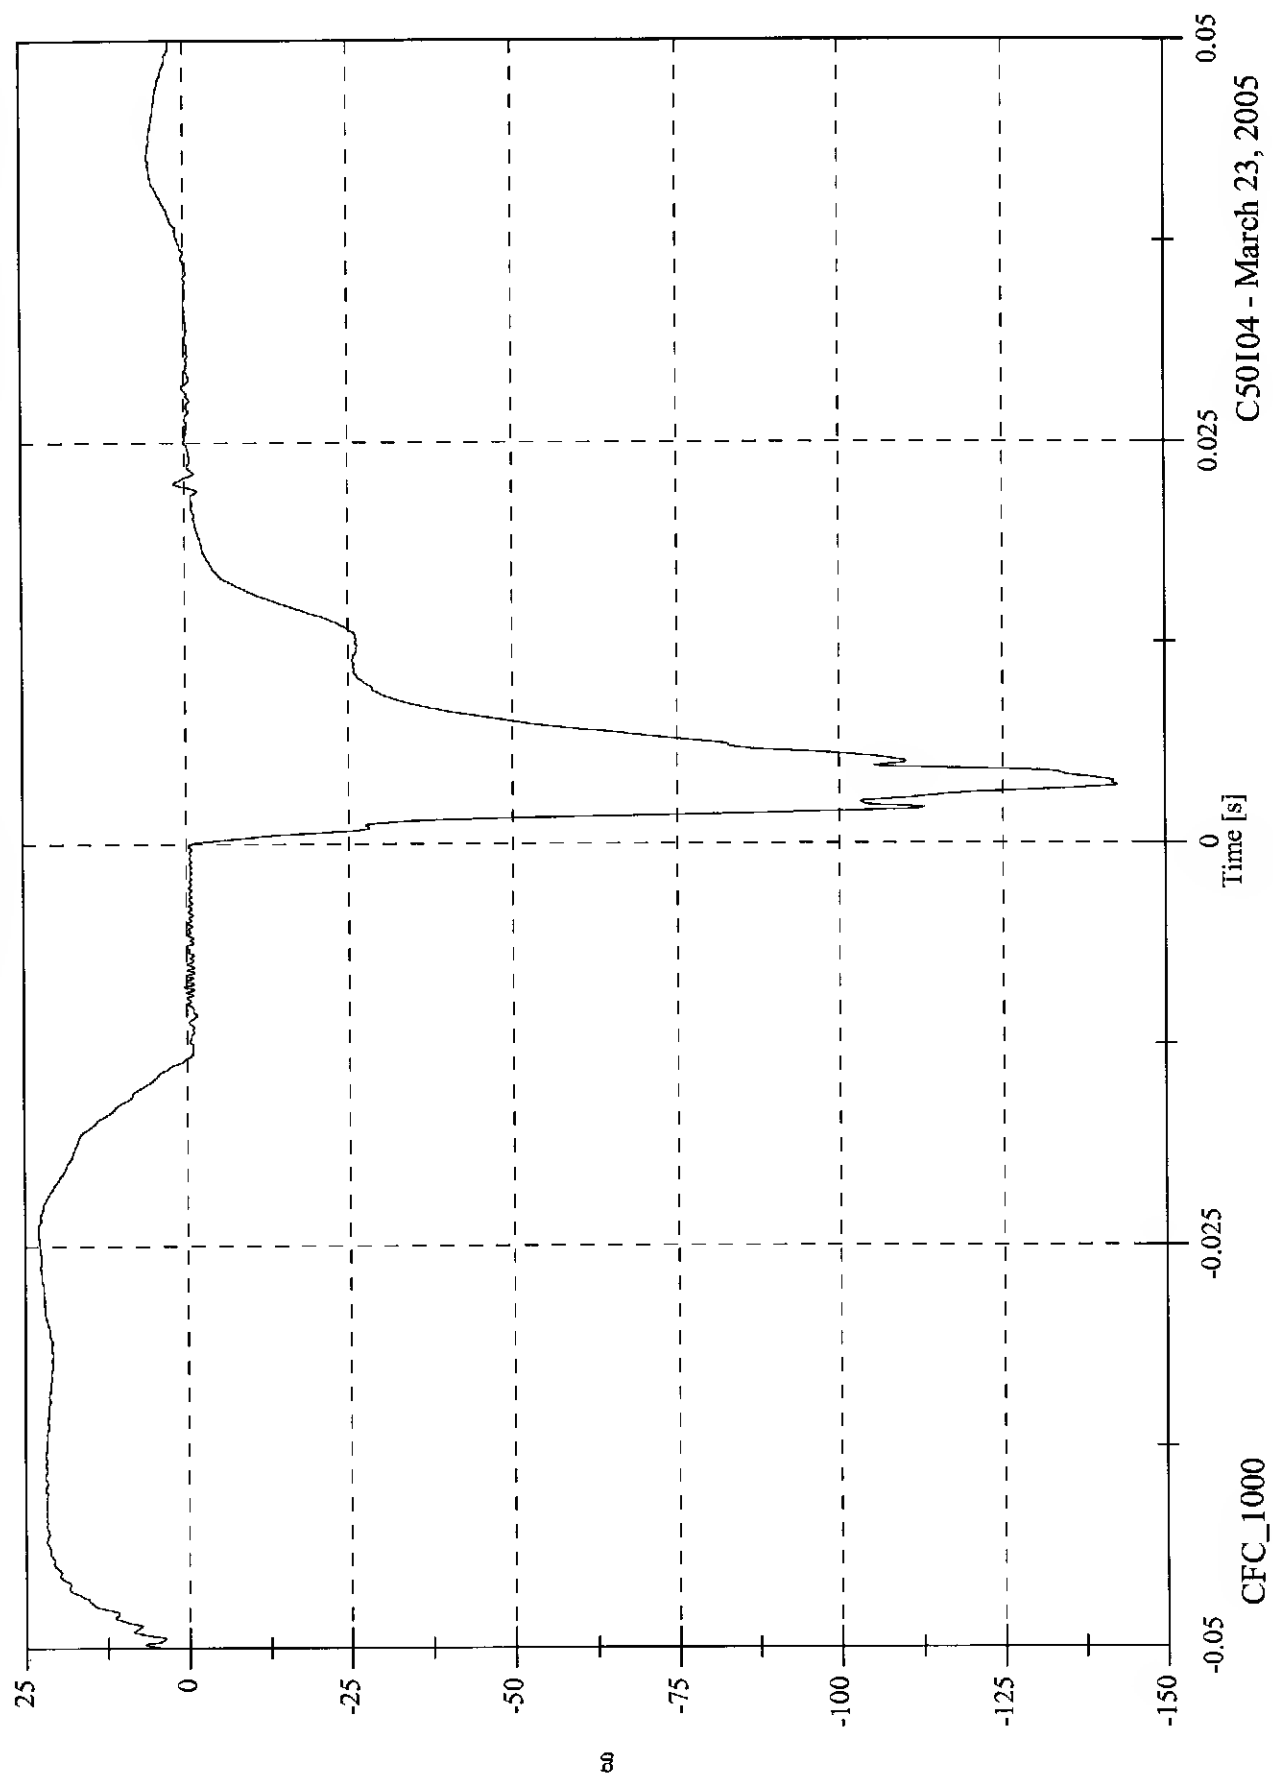
Max: 22.9 [g] at -0.024 [s]
Min: -142.6 [g] at 0.004 [s]

FMVSS 201U IMPACT TEST - 2005 Buick Lacrosse Sedan
Headform X Acceleration

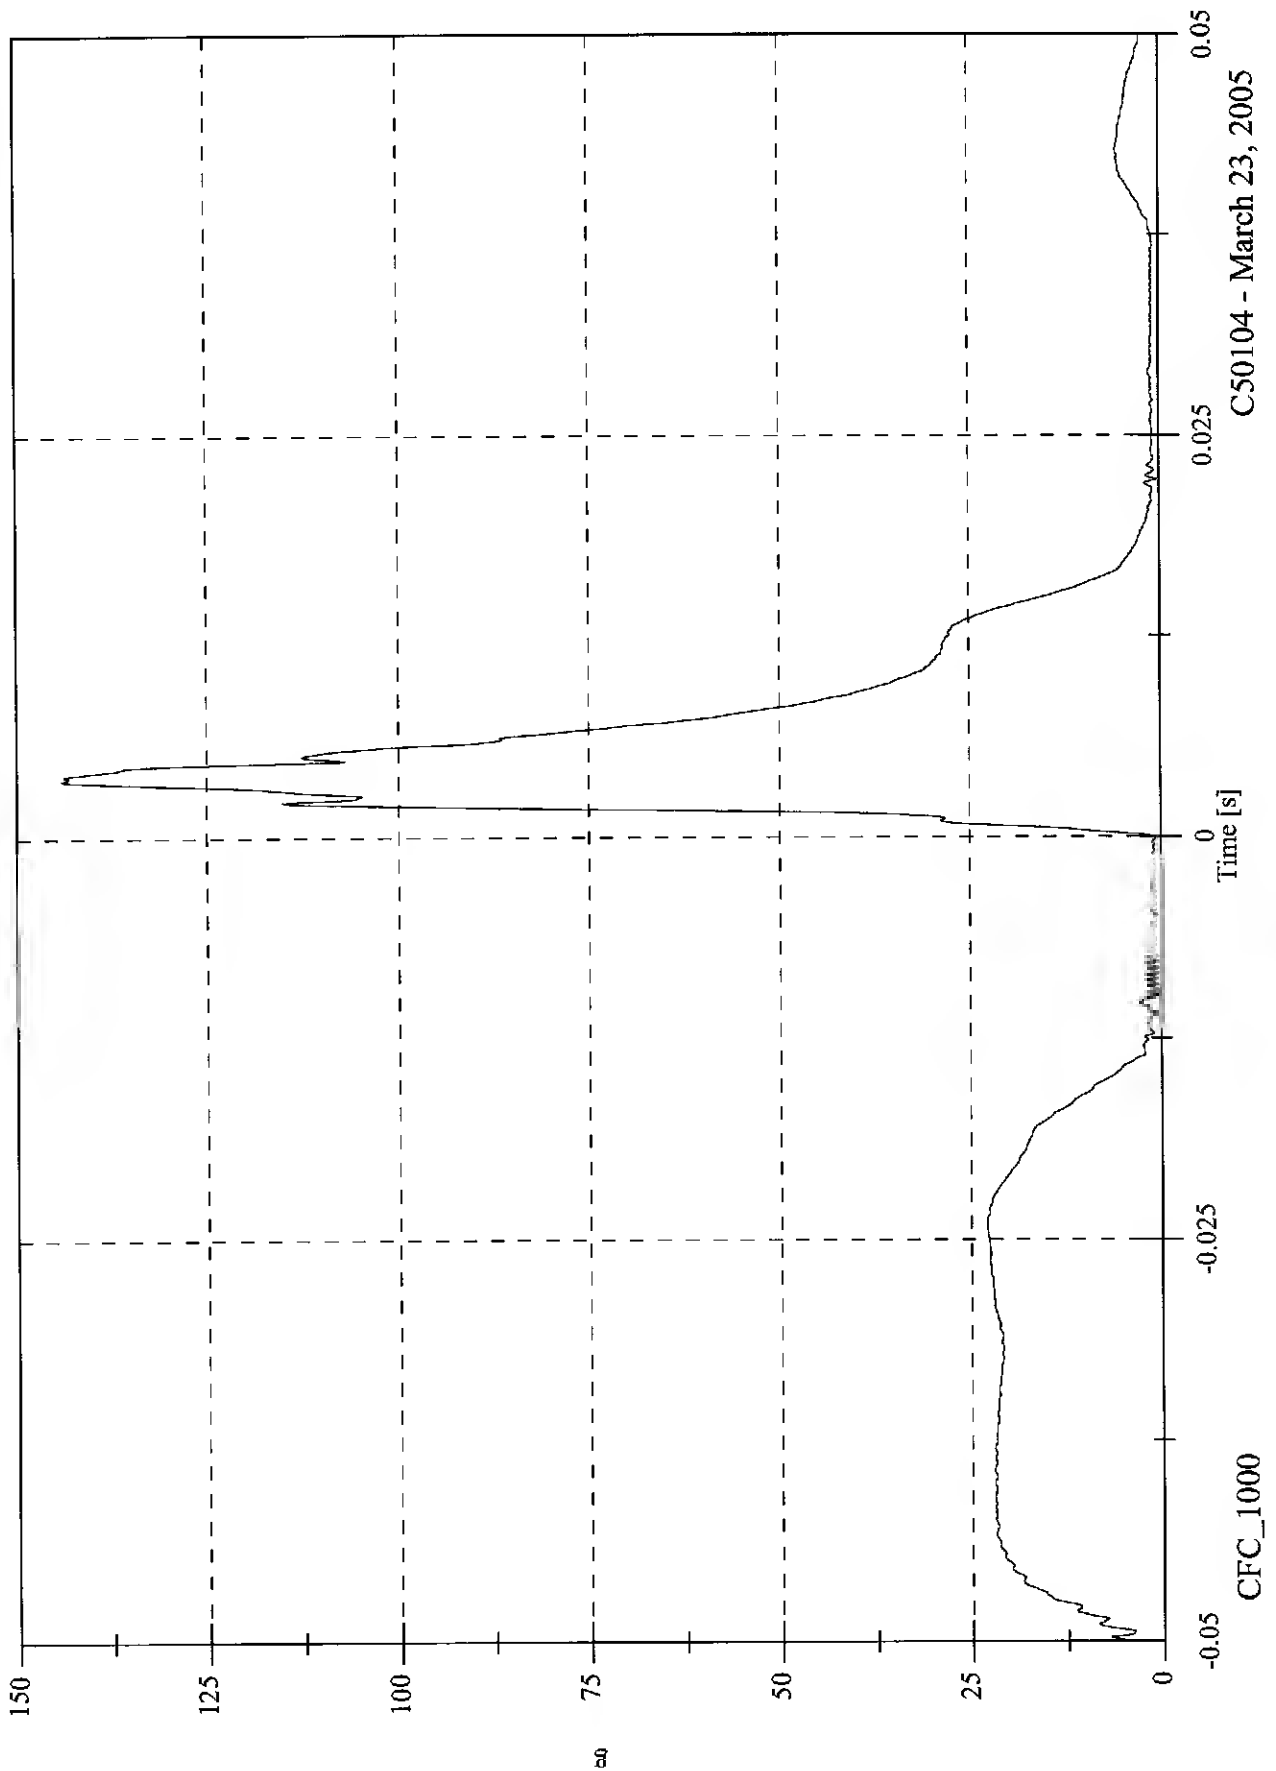
Max: 144.2 [g] at 0.004 [s]

Min: 0.1 [g] at -0.008 [s]
